Kelvingrove Art Gallery and Museum

Infrastructure Support Conservation Plan
August 2025

Phase 1: Port Cochere Scope

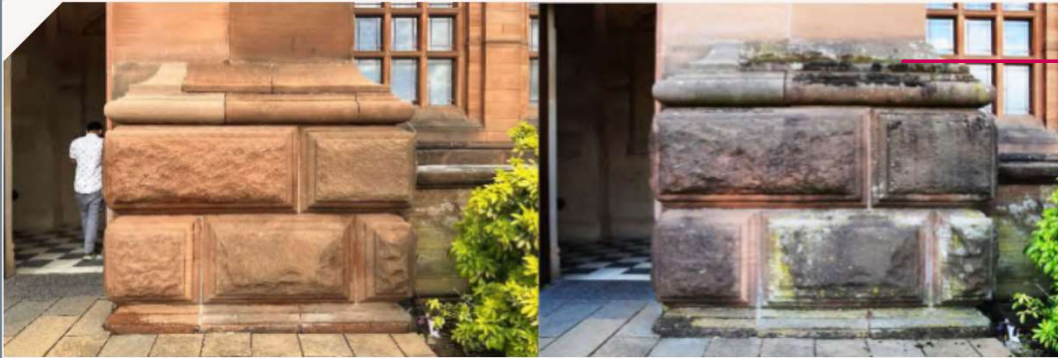
STONework

Digital Scan, Removal of Cementitious Repairs, Removal of greening to stone, Mortar Analysis, Petrographic Analysis.

Adjustments to DoFF cleaning methodology required to obtain consent.

Repoint on 100% basis using lime-based mortar.

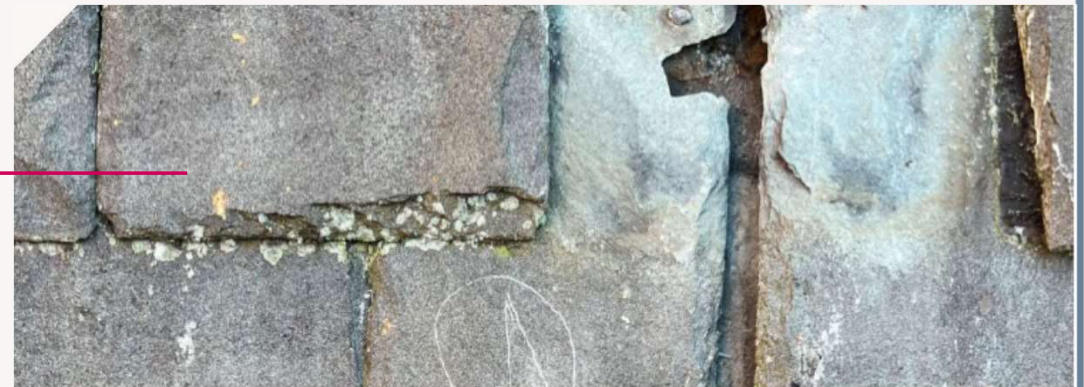
SLATERWORK

Digital Scan, Slate Analysis to determine the origin.

Long lead in time for procurement.

Replace with new slate, Westmorland Greens.

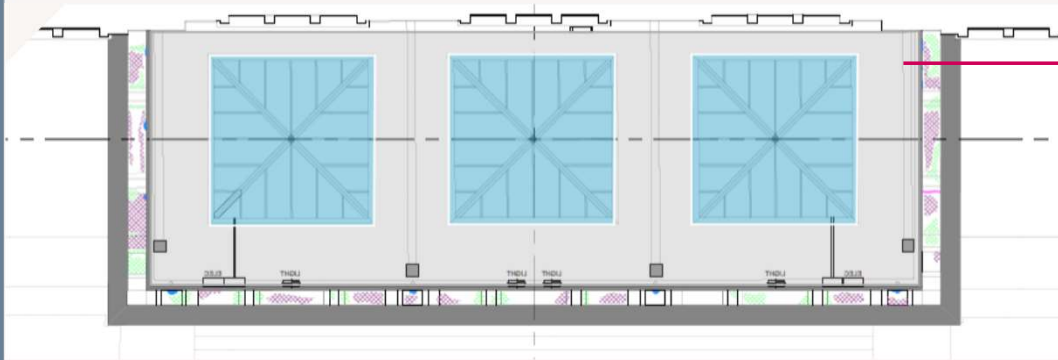
ASPHALT ROOF

Sampling taken to determine build up.

Previous repairs poor.

Repairable rather than full replacement, however, replacement now planned to ensure longevity.

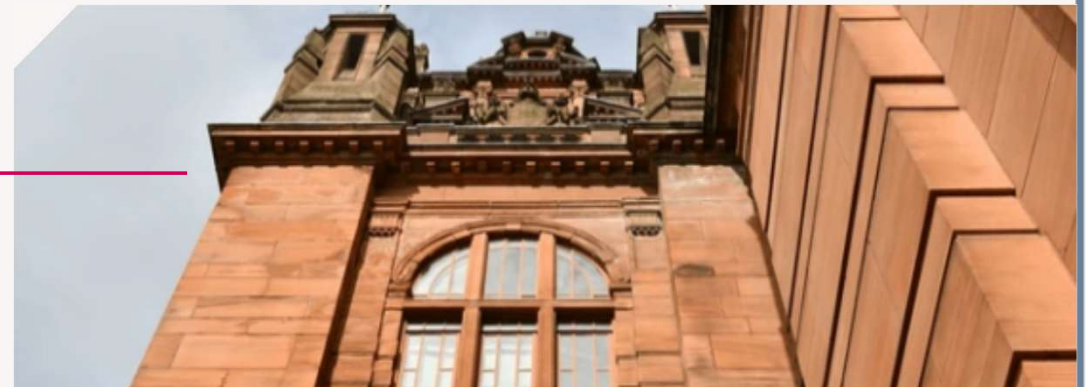
WINDOWS

Visual Inspection by Shepley Engineers, Trial Window Removal, ACM Refurbishment Survey.

Repairs need to be carried out in situ.

Treat corrosion, reglaze, refinish, repaint.

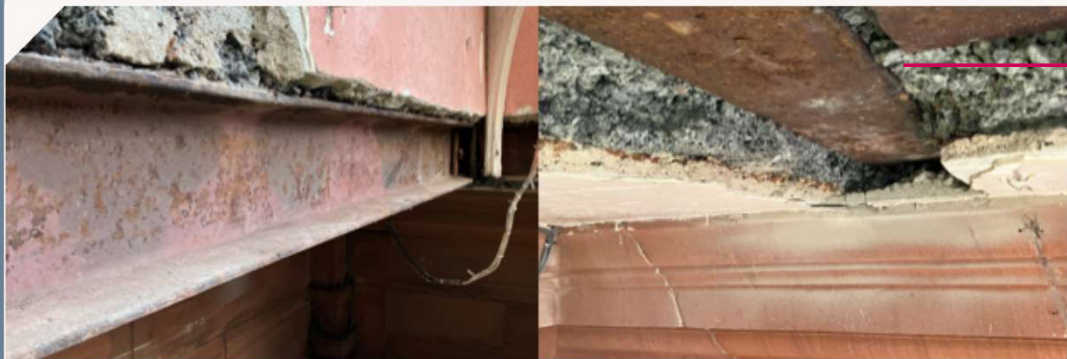
ROOF STRUCTURE

Investigations: Visual Inspection.

More invasive intervention may be required e.g. welding and cutting.

Repair damage to substructure caused by water ingress.

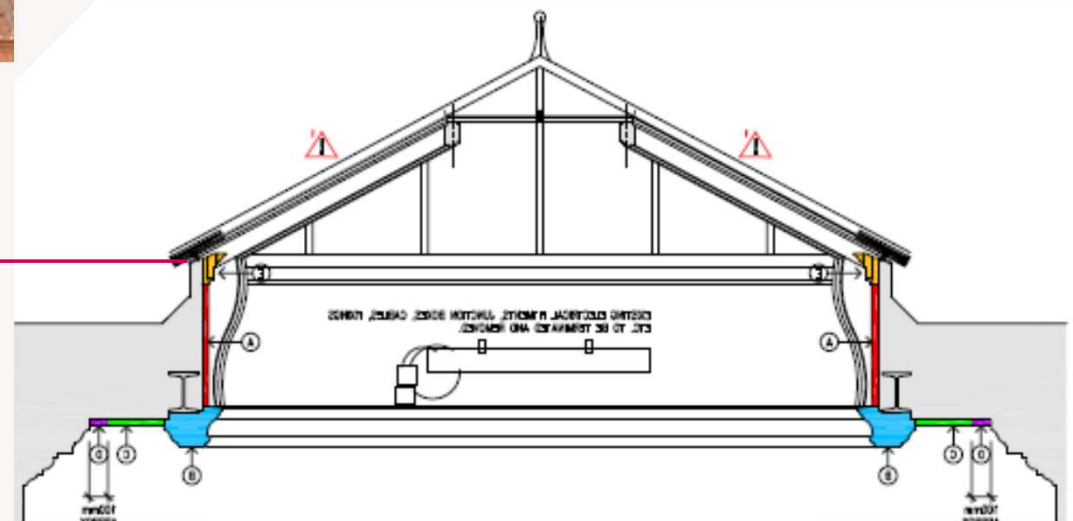
ROOF LANTERNS

Visual Inspection and Rot Survey.

Condition of lanterns allowing rainwater to penetrate, replacement glazing, flashings and glazing bars required.

Scope to be determined post removal.

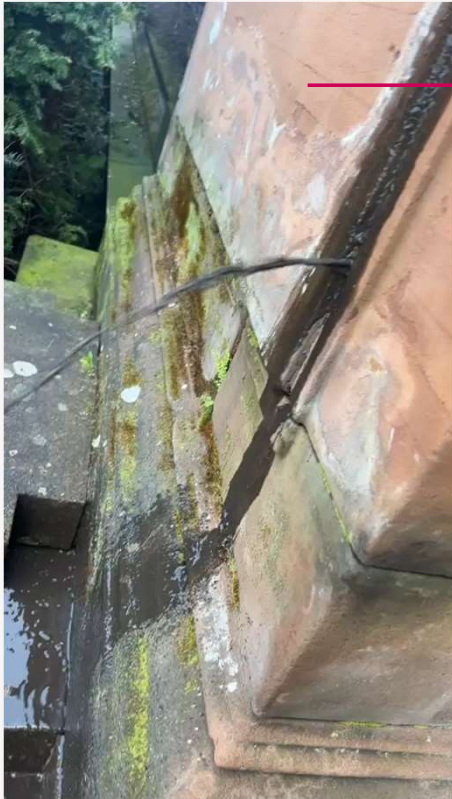
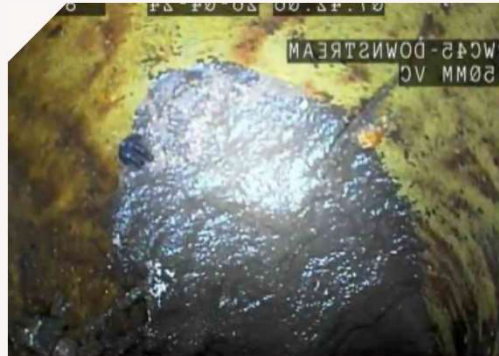
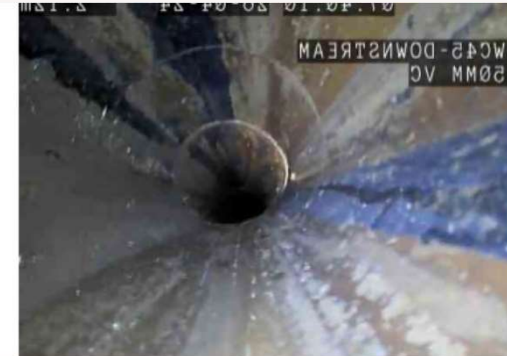
ROOF DRAINAGE

Visual Inspection and CCTV Survey.

4 conductors blocked; further action required to establish issues, consider future maintenance options.

Breach in pipework, removal of stonework panel may be required.

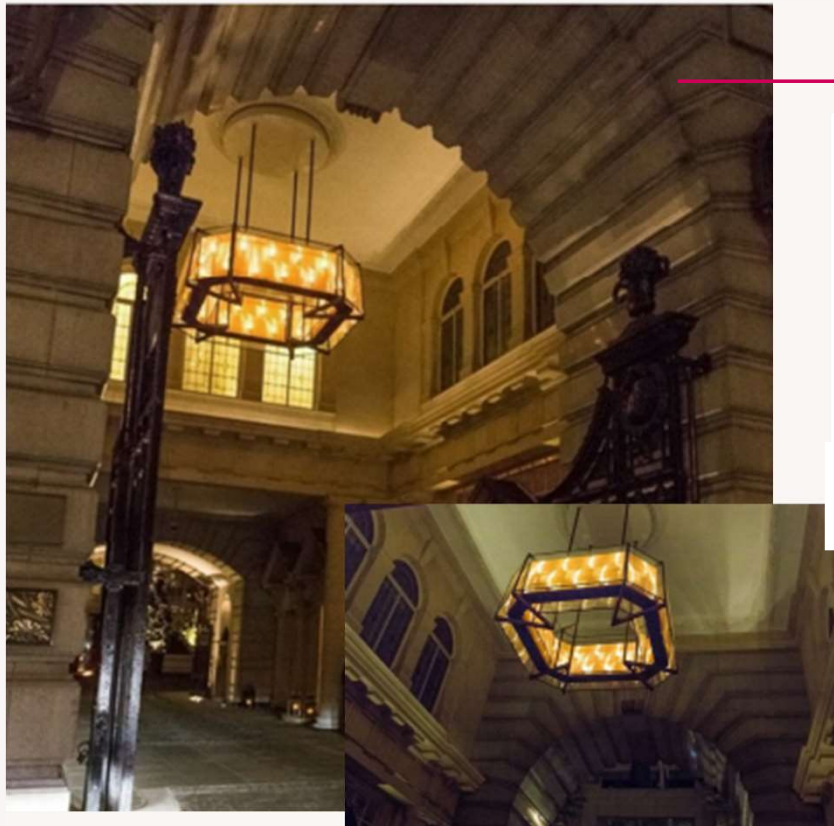
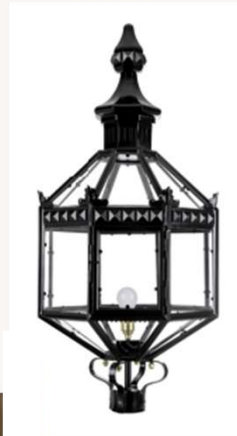
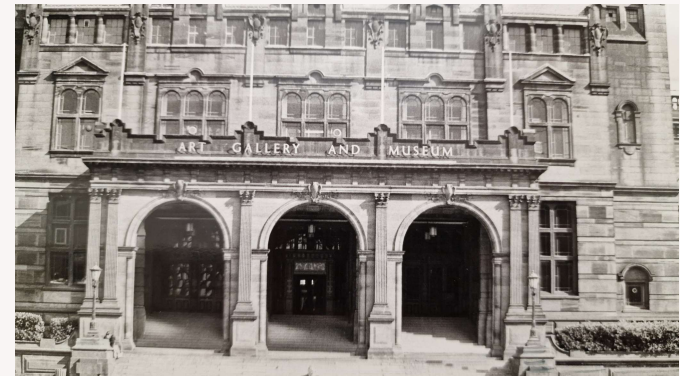
LIGHTING

Existing lighting design traced and disconnected and site survey by Clancy's.

Existing light fitting aesthetically poor and does not reflect the status of the building, suggest reverting to original design intent with pendant lighting.

Lack of evidence depicting original design intent therefore, planners may reject this proposal.
