11th September 2026

**Maryhill Area Partnership.**

**Report by Head of Policy and Corporate Governance**

### **Neighbourhood Infrastructure Improvement Fund (NIIF) – New Proposals**

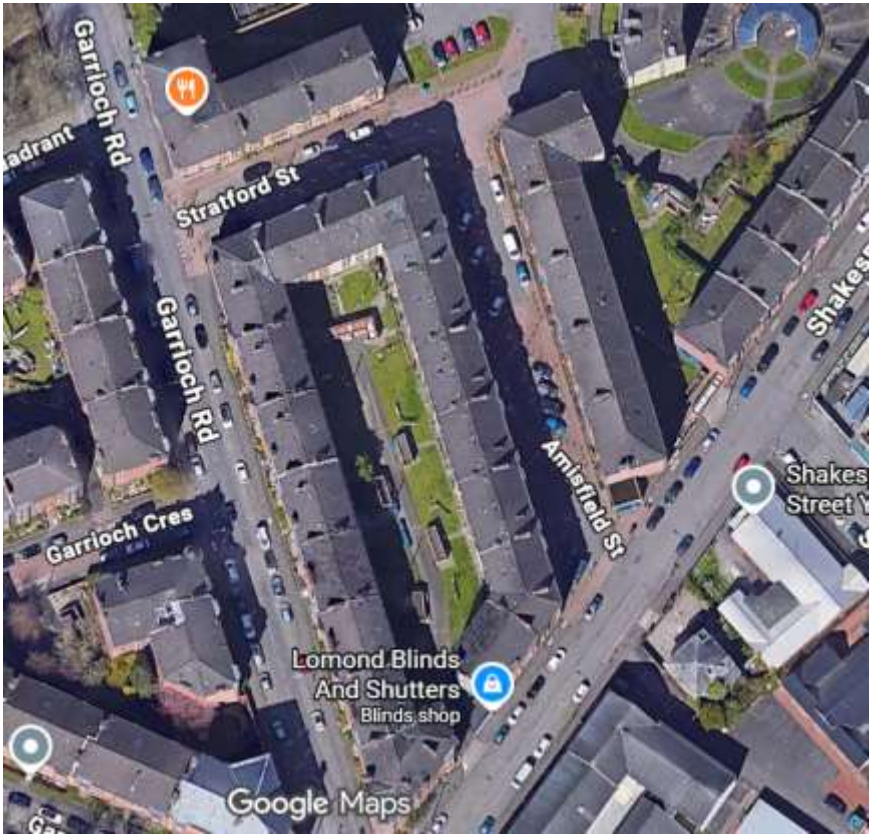
| Description of work required for Estimate -<br>Please provide as detailed a description as possible including type of work required, number and type of items required/special considerations or known issues etc | Location of Work required for Estimate -<br>Please provide a detailed description of the EXACT location (Street Name & Extents) of work required: |
|---|---|
| <p>1) All footways, speed tables and inserts that are mono blocked to be resurfaced with tar</p> <ul style="list-style-type: none"><li>• All Bollards within Stratford &amp; Amisfield Street to be repainted</li><li>• Pavements &amp; sections of the road have old block paving that is damaged</li></ul> | Stratford Street & Amisfield Street within Maryhill |

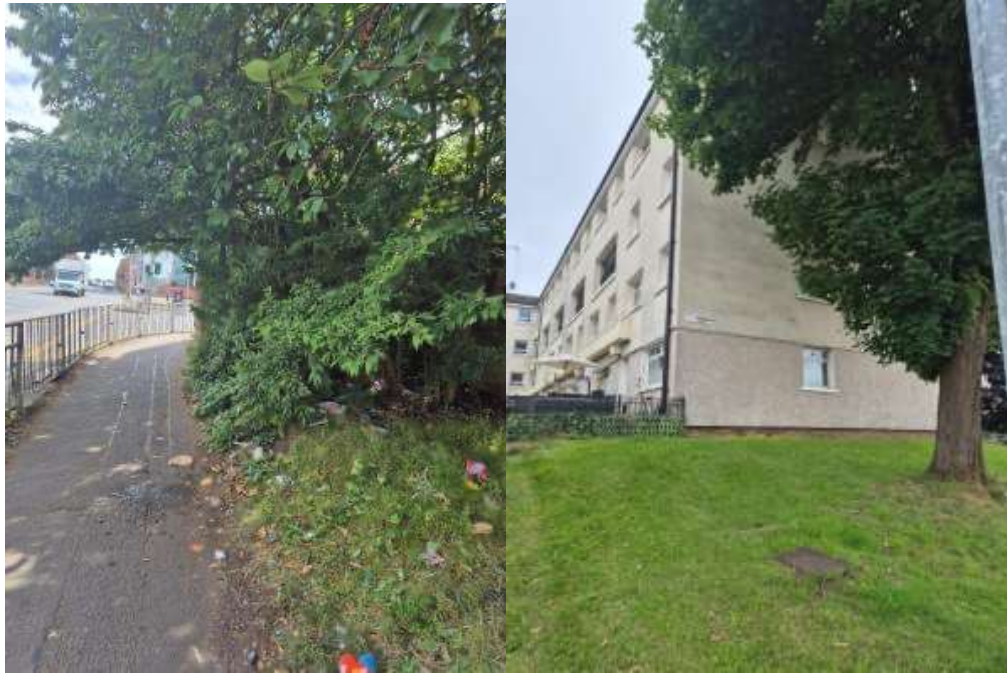
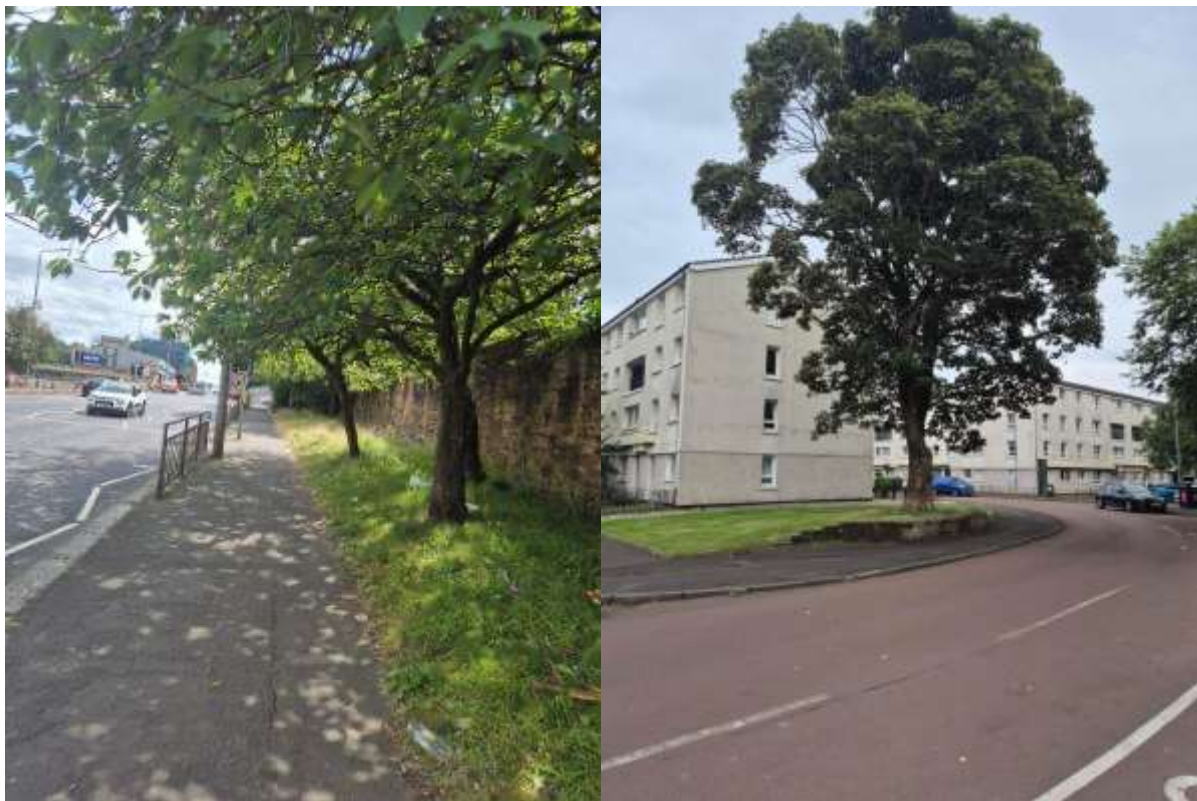
## 1. Tree trimming around the Wyndford Estate

| 2) The tree surgeon to cut down tree sizes around the Central Maryhill Area but mostly in the Wyndford estate and at the canal steps in Shakespeare Street going up to the Ruchill estate. | Bushes and trees at the canal bank and steps in Shakespeare Street just along from the church and McDonalds.<br><br>Ross MacPhail has advised any Tree related work would likely be Business as Usual (BAU). |

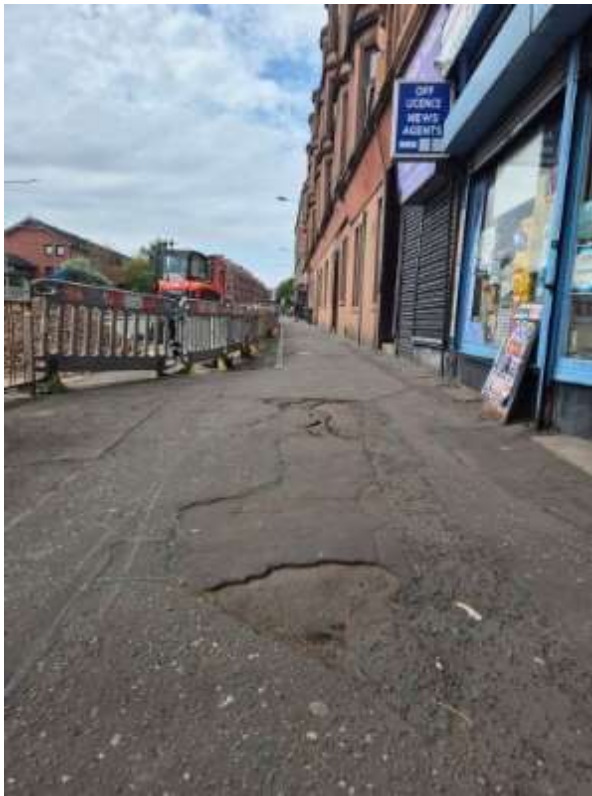
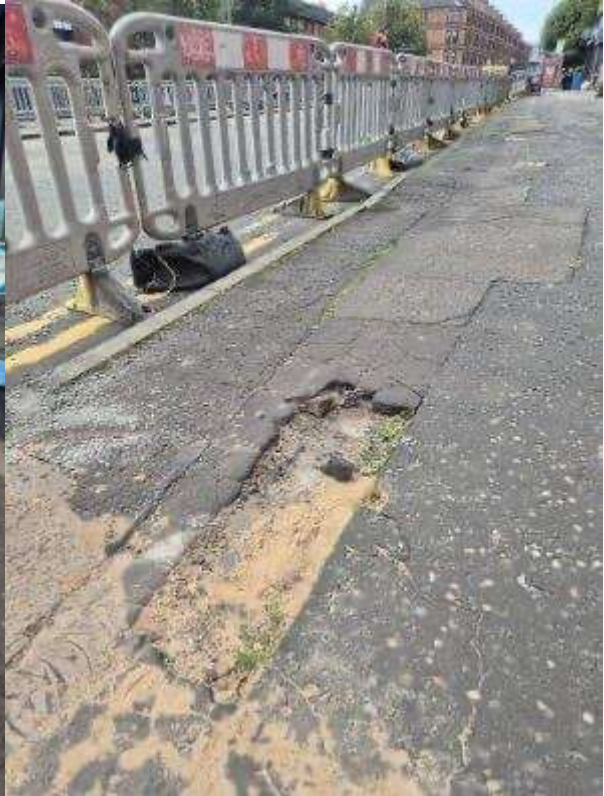
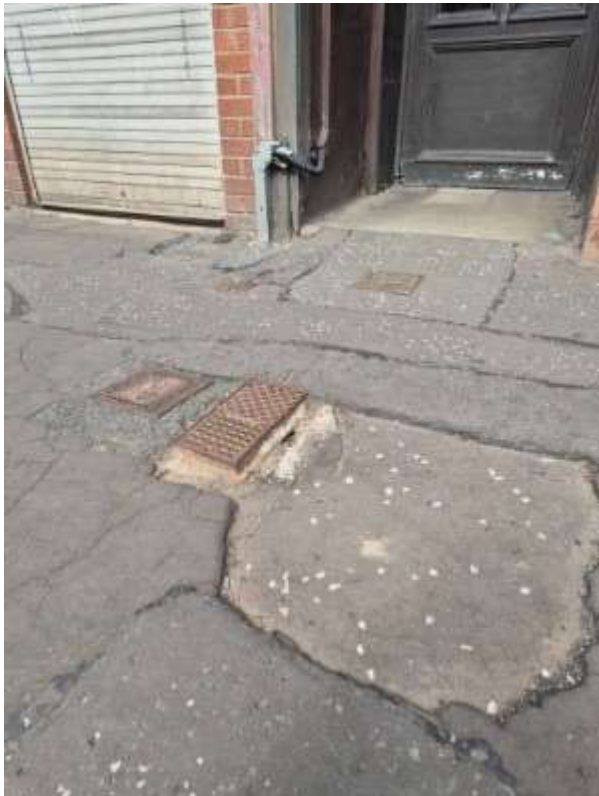
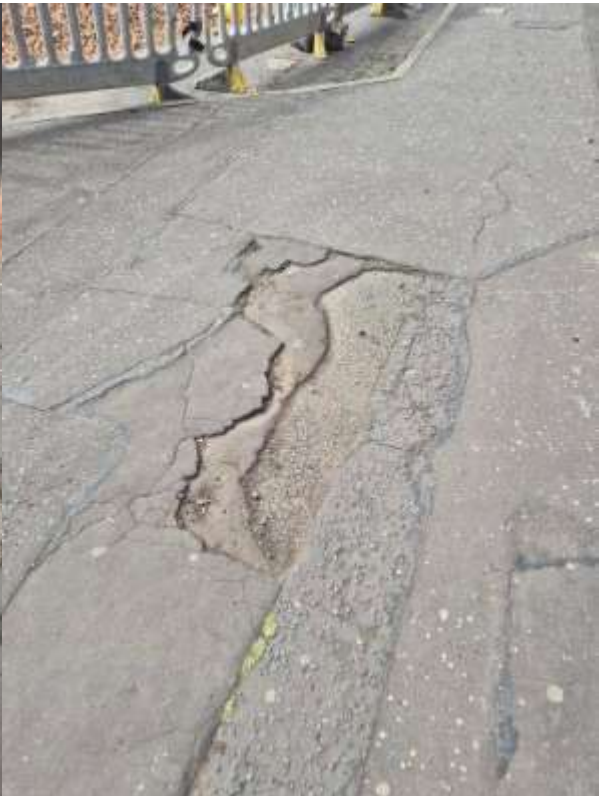
### 3. Paving around Wyndford Estate

| 3) Paving around the Wyndford estate which is needing repaired | Bisland Drive to East Park Home |

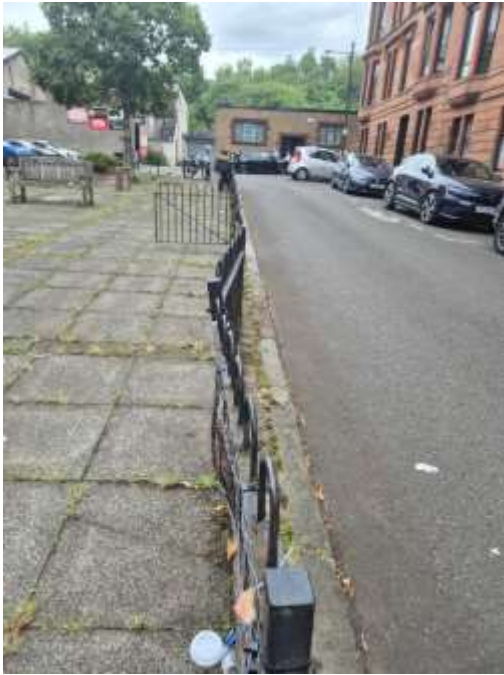
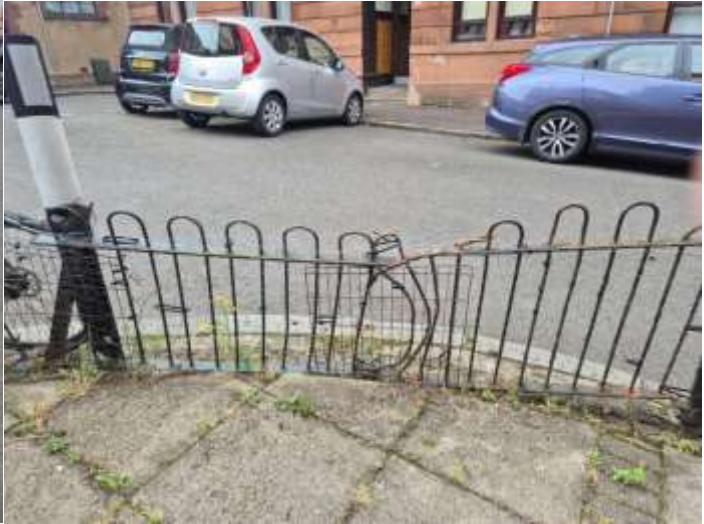
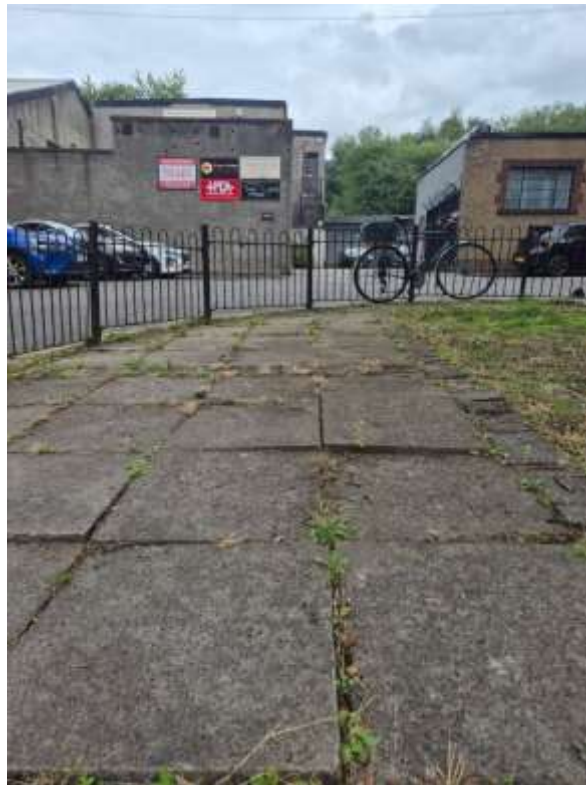
## 6. Leyden Gardens –

| 6) Leyden Gardens (Leydon Street) – The community space is in despair and requires a full upgrade: | Leydon Gardens (Leydon Street) - Maryhill |

| <ul style="list-style-type: none"> <li>Fences round the garden are in dire condition and need repaired and repainted</li> <li>More benches required in the Gardens</li> <li>Unlevelled paving in gardens need repaired</li> </ul> | |

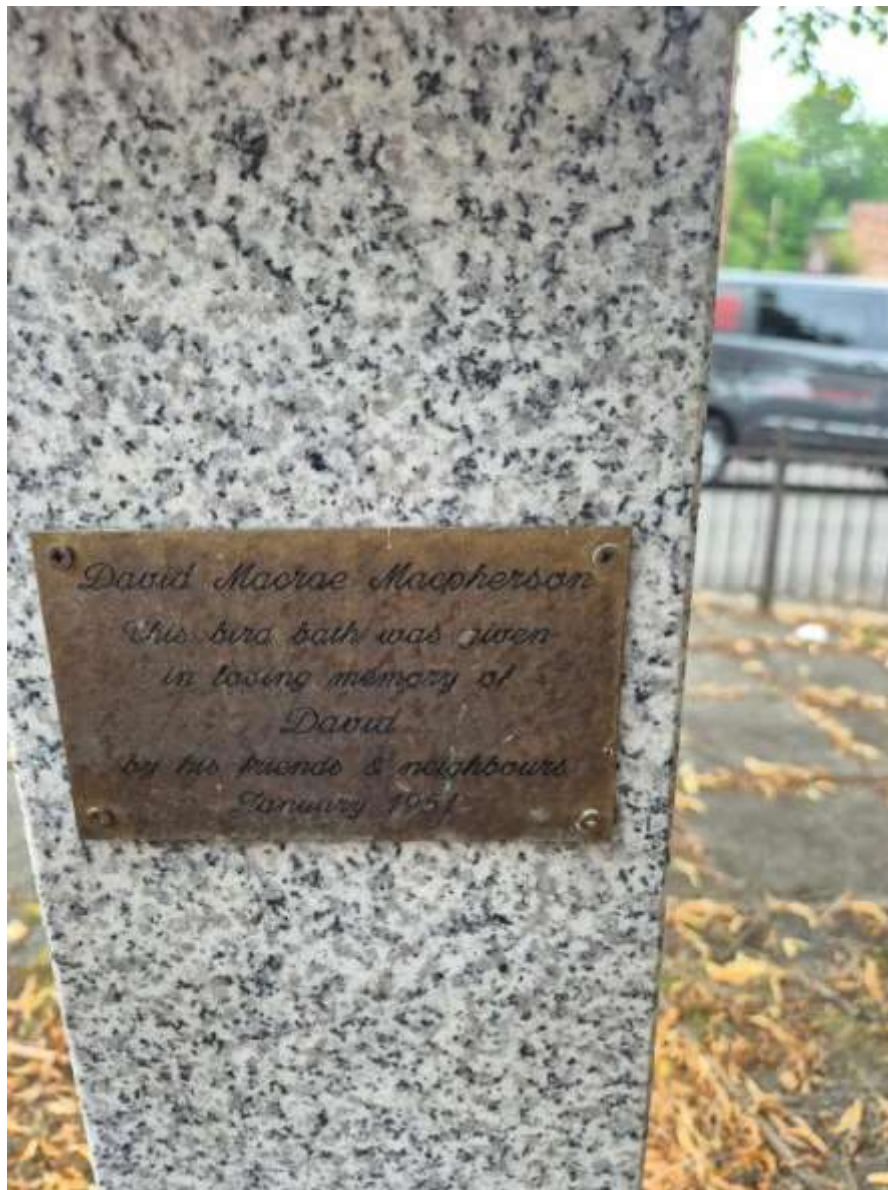
## 7. Memorial State – Leyden Gardens

| <b>7) Memorial Statue of David Macrae Macpherson has been damaged – repairs/upgrade required by members of the community</b> | <b>Leydon Gardens (Leydon Street) - Maryhill</b><br><br>Monument is within Leydon Gardens |

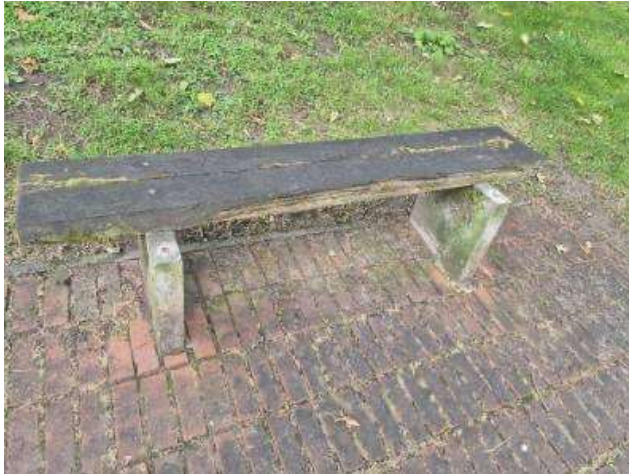
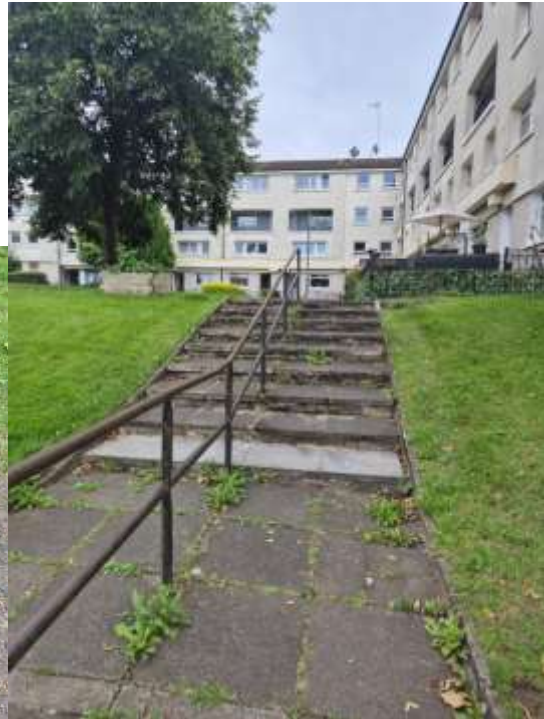
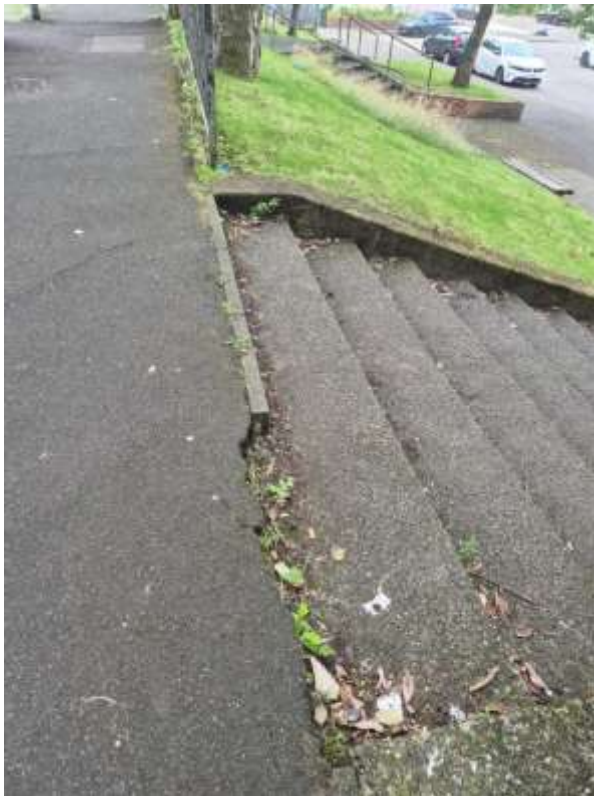
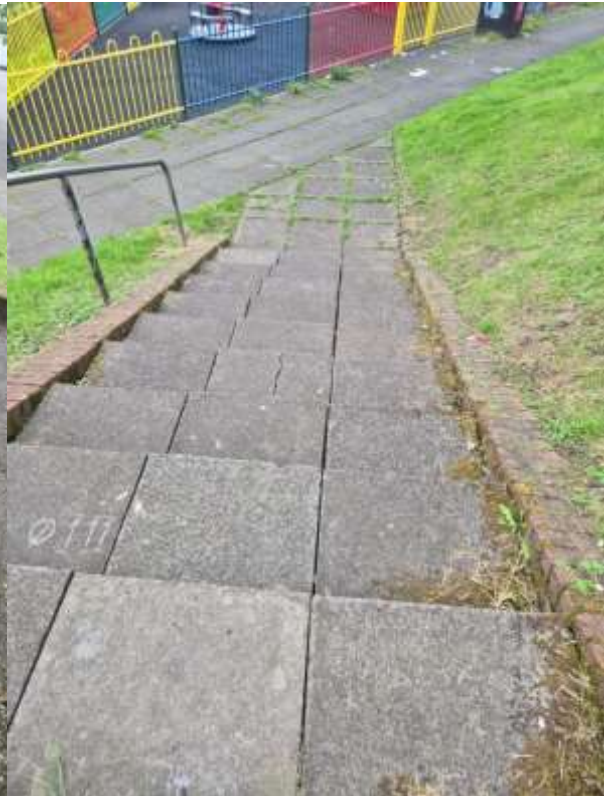
## 8. Area around Wyndford Nursery

| <b>8) Improvements to Area along Wyndford Nursery</b> <ul style="list-style-type: none"> <li>Benches are broken and need repaired</li> <li>Some slabs on the stair wells going down to the nursery need repaired and cleaned from moss– accessibility issue for parents and children as there is no ramp</li> </ul> | <b>Glenfinnan road along Wyndford Nursery</b> |

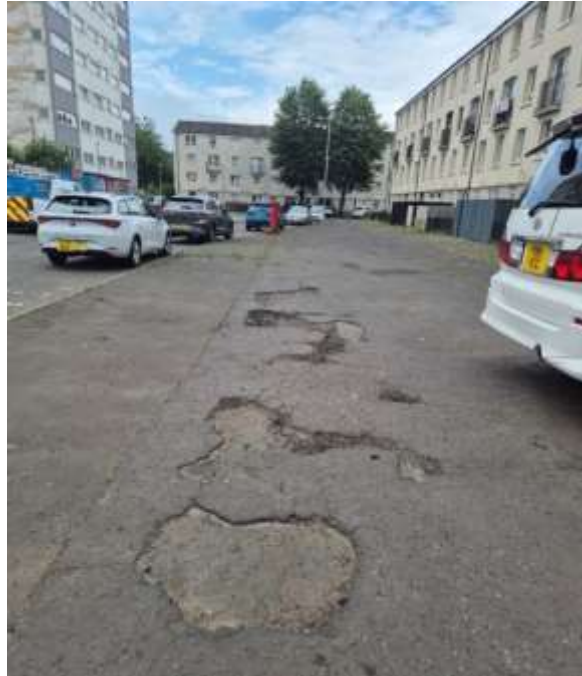
## 9. Invershin Drive

| <b>9) Pavement at Invershin Drive needs repaired</b> | <b>Invershin Drive, Maryhill</b><br><br> |

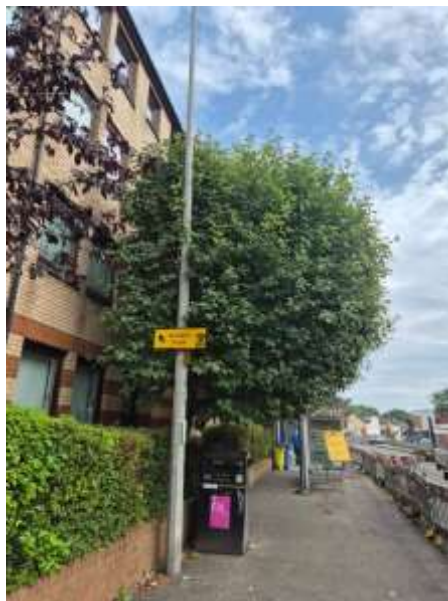
## 10. Tree Trimming at Maryhill Road at Eastpark home

| <b>10) Tree needs trimmed/cut down</b> | <b>Maryhill Road at Eastpark home</b> |

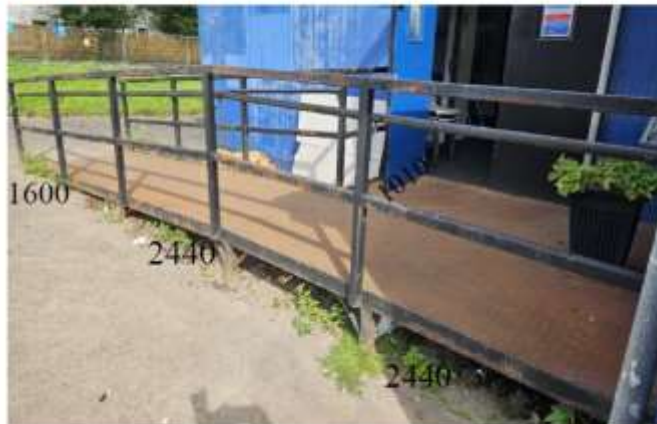
Ramp comprises of :

- A. Mild steel durbar floor plates - 4 x 2500 x 1250 x 4.5mm
- B. Hollow section handrail and brackets.
- C. 60mm Sq hollow section legs corroded.
- D. Support rails can be reused - cut out box packer / replace.
- E. Cross members to be replaced.
- F. Provide options for painted ramp plates and for Galvanised.

- Carefully cut out corroded hollow section side rail packers and cross bracing.
- Replace corroded support legs where required.
- Install new side rails from angle section, welded to existing 10mm thick stringers.
- Install new cross bracing.
- Cut and lay in new 4.5mm mild steel durbar plates.
- Cut out corroded step treads.
- Replace with 40 x 265 x 40 x 4.5mm treads, welded to stringers.
- Allow for all welding and fixings.
- New material primed / undercoated and one coat Combi Black applied.
- Plant and Labour in the works.

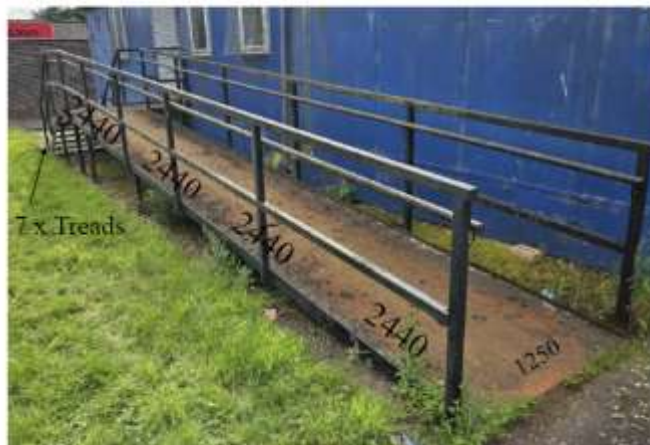
Ramp comprises of :

- A. Mild steel durbar floor plates - 4 x 2500 x 1250 x 4.5mm and 1 x 2000 x 1000 x 4.5mm
- B. Hollow section handrail and brackets.
- C. 60mm Sq hollow section legs corroded.
- D. Support rails can be reused - cut out box packer / replace.
- E. Cross members to be replaced.
- F. Provide options for painted ramp plates and for Galvanised.
- G. Seven folded trends require replacement.

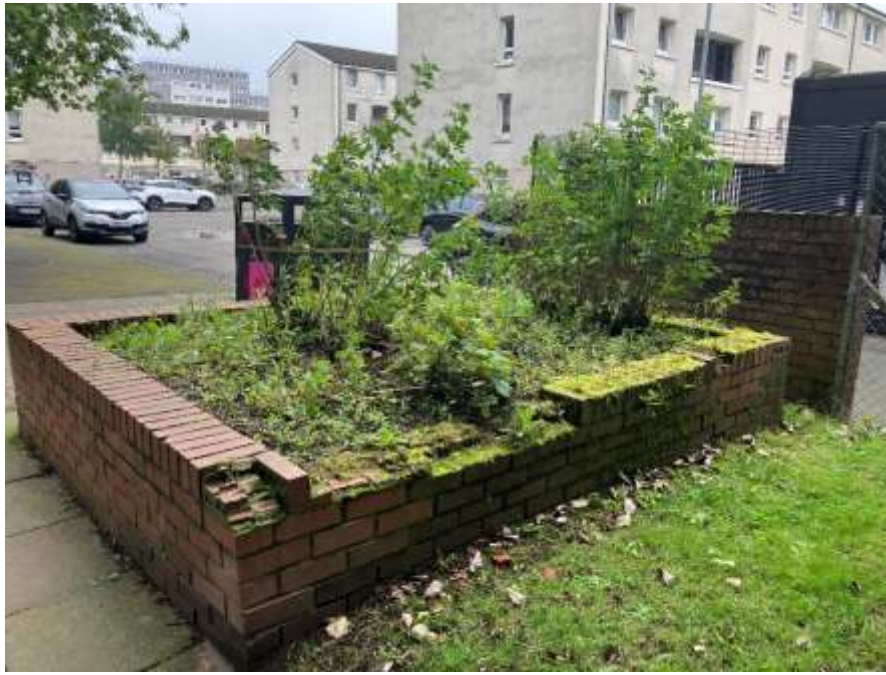
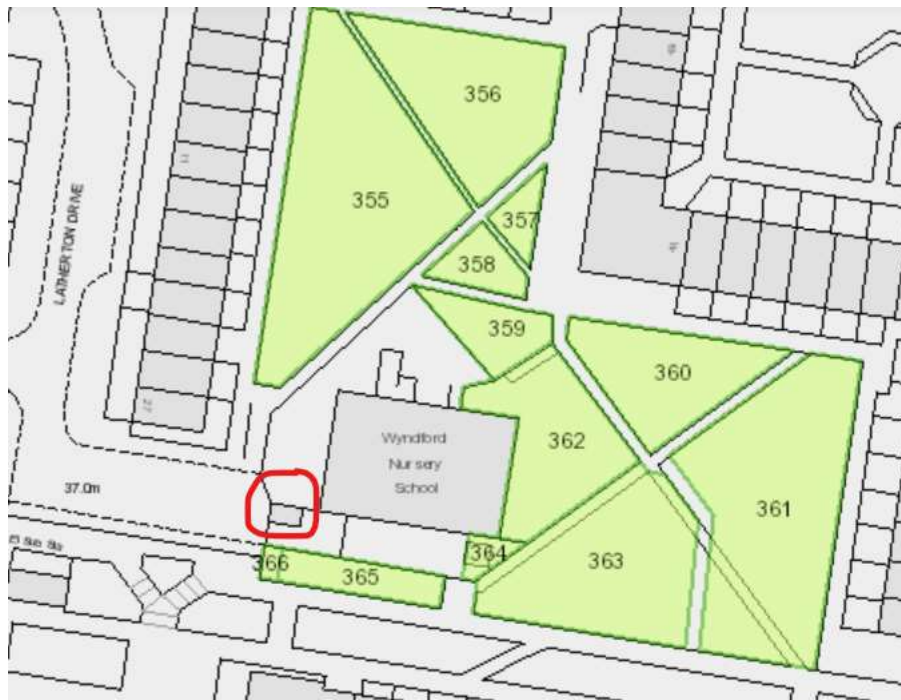
| <b>Description of work required for Estimate -<br/>Please provide as detailed a description as possible<br/>including type of work required, number and type of<br/>items required/special considerations or known<br/>issues etc</b> | <b>Location of Work<br/>required for Estimate -<br/>Please provide a<br/>detailed description<br/>of the EXACT<br/>location (Street<br/>Name &amp; Extents) of<br/>work required:</b> |
|---|---|
| <b>13) Repair planter and remove 4 wild roses within<br/>planter</b> | <b>Planter near<br/>Wyndford Nursery<br/>(33 Latherton Dr,<br/>Glasgow G20 8JR)</b> |
