The Dovecot

**Engineers Planning Stage Summary
Report**

Flood Risk Assessment

Extended Phase I Habitat Survey

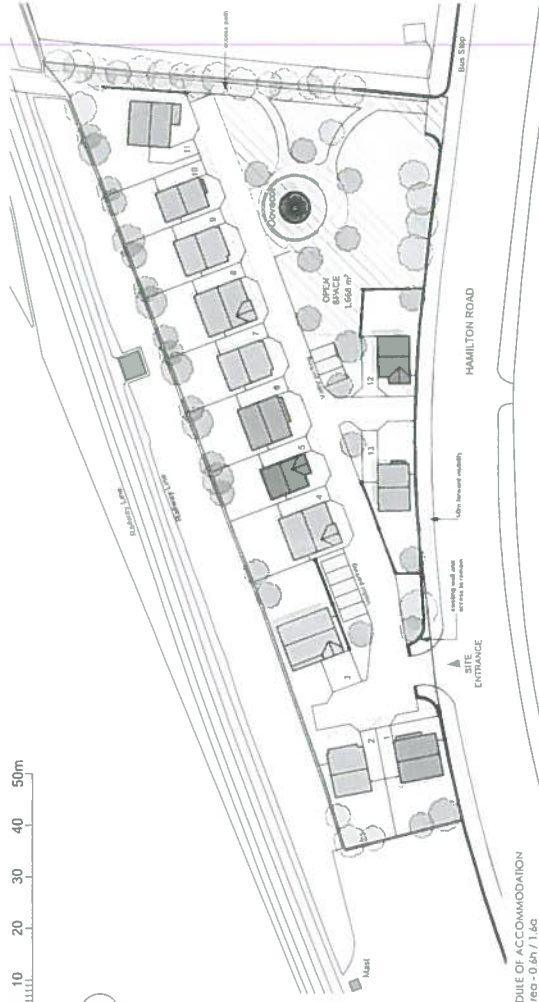
SCHEDULE OF ACCOMMODATION

Site Area - 0.81 / 1.6a
3 bed detached - 2no (950)
3 bed detached - 2no (950)
4 bed detached - 3no (1,160)
4 bed detached - 1no (1,200)
4 bed detached - 2no (1,250)
4 bed detached - 2no (1,300)
4 bed detached - 1no (1,500)
TOTAL - 13no Dwellings (9411)

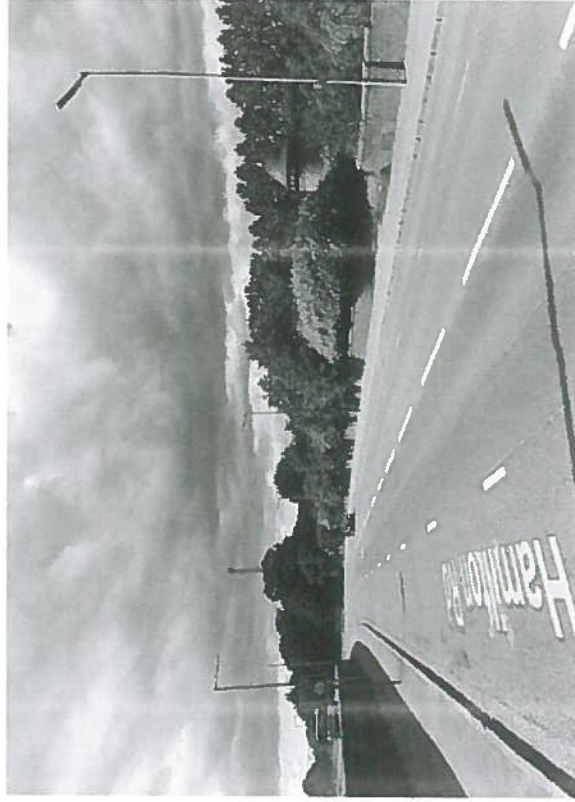
East Approach as Existing

A sensitive masterplan aims to encourage views of the Daldowie Doocot to encourage public knowledge and interaction. The only angle visible from the road (below) will be enhanced by similar viewpoints as one drives or walks past the site. More inviting public access on the east of the site aims to encourage the public into a redefined park containing the doocot. The presence of a bus stop adjacent to this entrance both provides travellers with a pleasant place to wait as well as good public transport for residents.

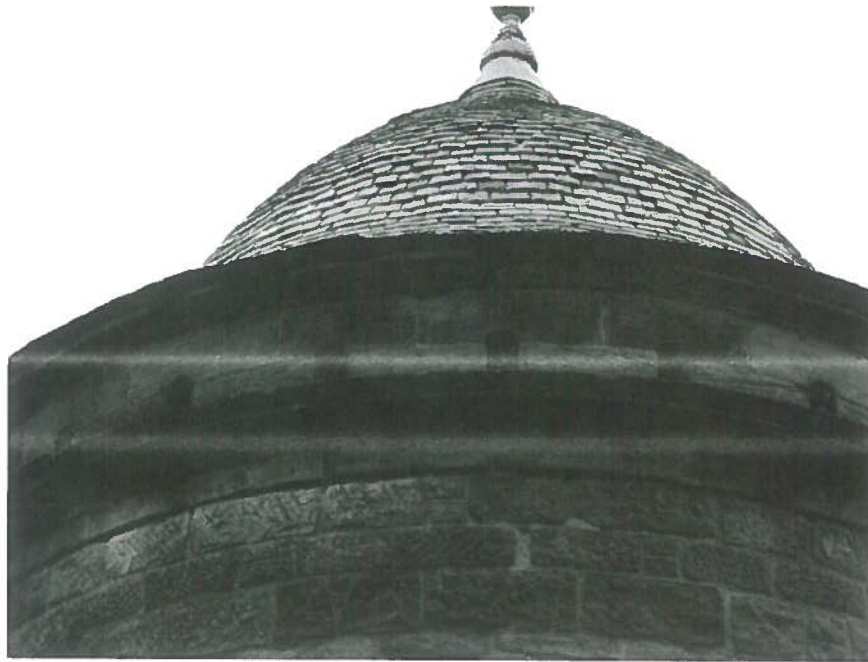
Plate 9. Dovecote showing crevices at wall head and gaps under slates

loose or missing panels or cracks and crevices, loose flashing etc. on the building. Each potential access point was examined (with binoculars if not accessible for close examination) for signs indicative of use by bats such as droppings, urine streaking, polished, or worn surfaces, or staining marks at the potential entry point. The ground along the walls was also checked for dropping accumulations, and walls and windows were also checked for the presence of occasional droppings. Internal access was not possible: the building was secured.

Following a high due regard for the possibility that bats could roost in the building we recommend that a series of two bat presence/absence surveys should be completed. The surveys must follow the new bat survey guidelines or any subsequent updated guidelines and:

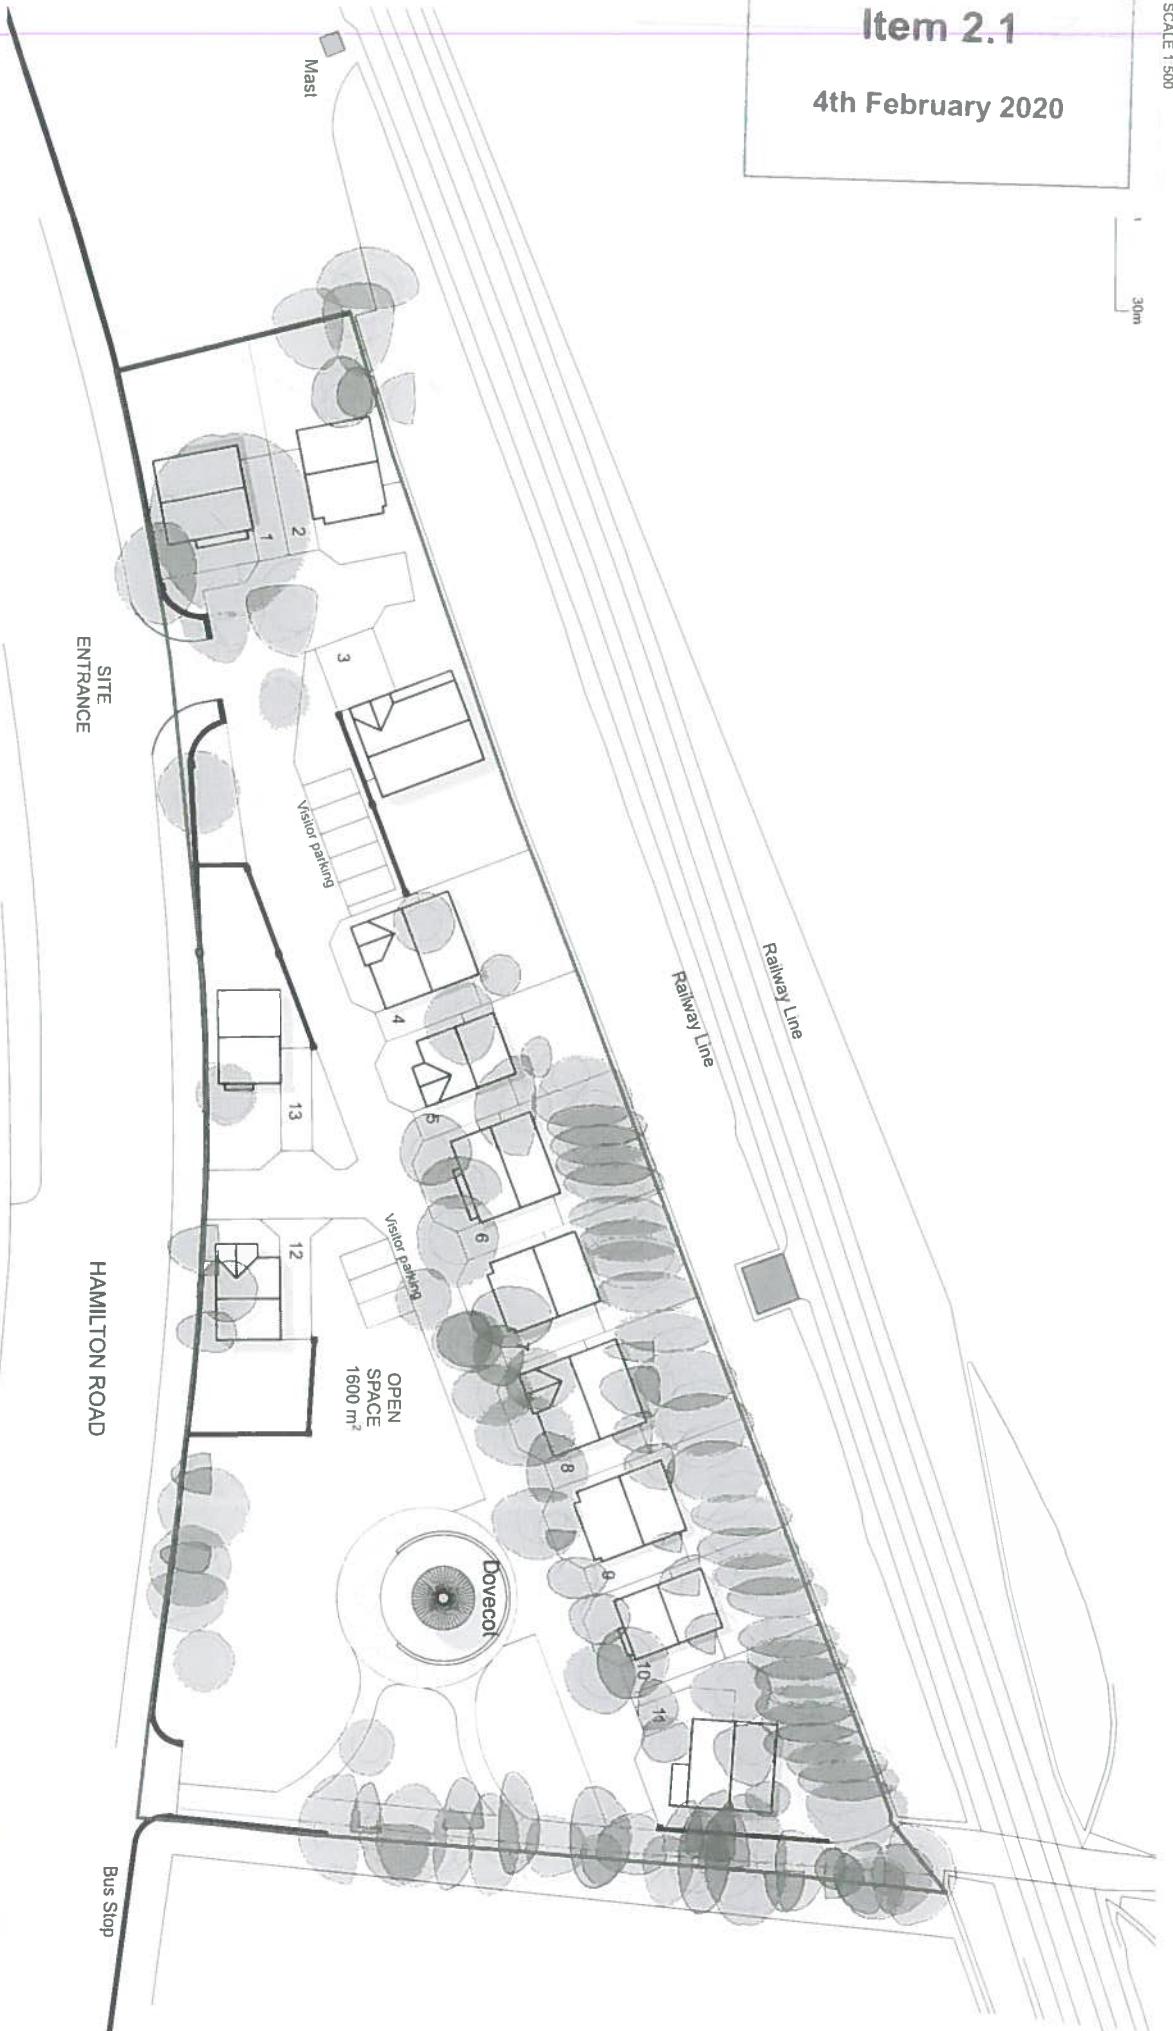
TREE SURVEY CATEGORY

- A 40+ years
- B 20-40 years
- C no effort to retain
- U no effort to retain
